**Review of the Final Report Environmental status of the
Falmouth Cruise Ship Pier, Falmouth, Trelawny
prepared by CL Environmental, Kingston, Jamaica
for the Port Authority of Jamaica
July 2013**

**Diana McCaulay
Jamaica Environment Trust
September 2015**

September 2015

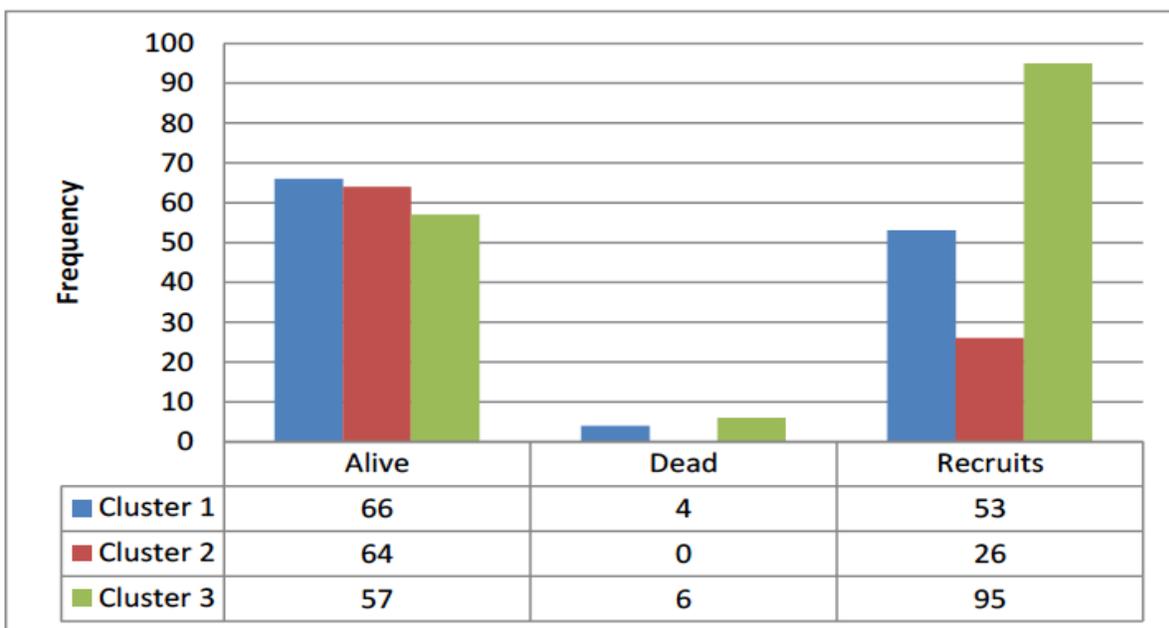
Figure 28 Graph showing summary data for each cluster

The use of two different types of artificial reef were required by NEPA, after a ship grounding event – Ecoreef Snowflakes and Reef Pyramids – but there is no information offered regarding the original state of the pyramids, which makes it difficult to interpret Figure 28 from the report:²⁰

The column for “Alive” is fairly meaningless without knowing how many corals were on these clusters and alive initially. The reader has no reference point for interpreting these results. Likewise, the number of recruits is difficult to understand. What sizes are these recruits? What is the likelihood for their survival? The reef pyramids showed some live coral from relocation, as well as the expected microalgae but beyond that very general observation, it is hard to assess the effects of using these pyramids as part of the restoration plan. The snowflakes were completely covered in microalgae and had no suitable cover for corals.

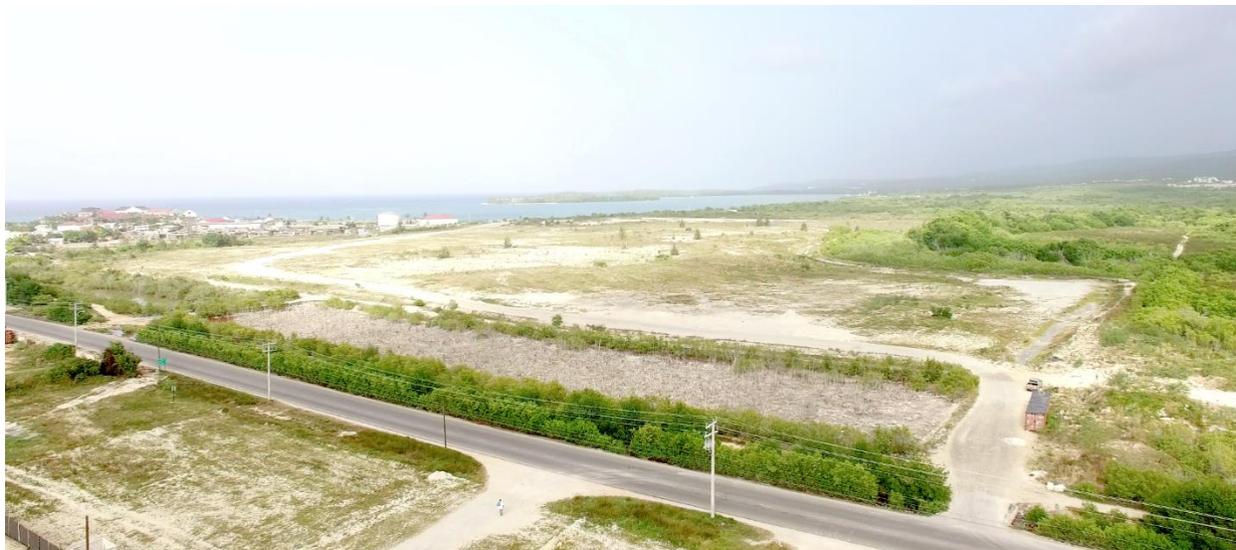
Photo: Windsor Research Centre 23 August 2015

The CL Report did not mention mangrove replanting. A large area of mangroves was cleared, dumped with dredge spoils, allegedly for a new market and parking, and remains in that state. A narrow strip of replanted mangroves all died.
